# Inherent Hazards and Limited Regulatory Oversight in the Waste Plastic Recycling Sector – Repeat Explosion at Pyrolysis Plant

Frank Huess Hedlund

COWI, Parallelsvej 2, DK-2800 Kongens Lyngby, Denmark  
 DTU/Compute. Technical University of Denmark DK-2800 Kongens Lyngby, Denmark  
 fhhe@cowi.com

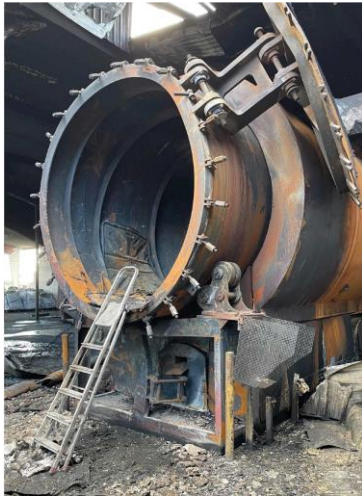
On October 8, 2021, a P4O pyrolysis reactor experienced a repeat internal explosion. Again, the explosion tore open the hinged endcap and the blast wave and ensuing fire caused extensive structural damage, the roof was gone and walls blown out (figures 2-5). There were no casualties as nobody was present.

The explosion took place during a full pyrolysis test run. The reactor was loaded with seven tonnes of baled waste plastic. The endcap was closed, bolts tightened, and nitrogen let into the reactor. At 07:15 oil burners were lit, and the pyrolysis process initiated. At 07:40 endcap bolts were re-tightened. At 07:45, when everybody was in the control room for a morning briefing, the reactor exploded. Burning liquid plastic flowed out of the open reactor and ignited baled waste plastic stored near the reactor. The company CEO briefly attempted to fight the

Figure 2 – Reactor endcap torn open, deformed, 2021

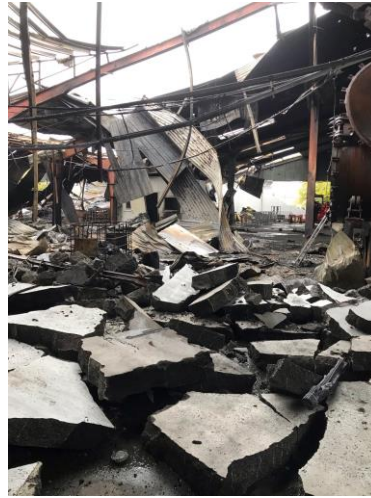
Figure 3 – Walls toppled due to explosion, roof gone, 2021

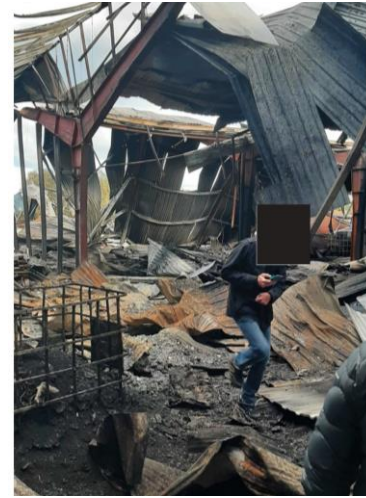
Figure 4 – Extensive fire damage, 2021

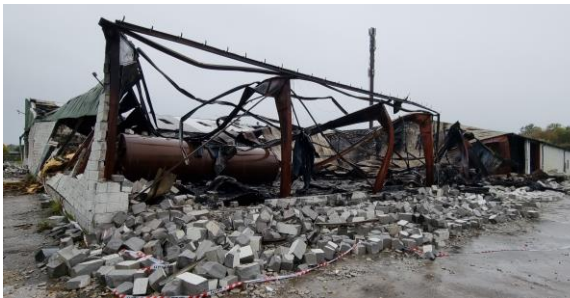
Figure 5 – Walls blown out, 2021

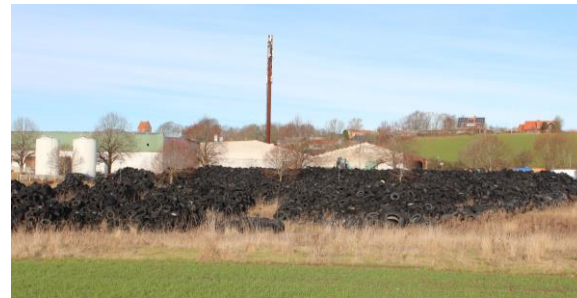
Large piles of about 1,000 tonnes of used car tires stacked on the premises added to the local discontent (figure 6). Two related but different legal companies did pyrolysis activities at the premises: The plastic P4O company and a tire T2O (Tire-2-Oil) company that was not damaged in the P4O explosions. A third related company owned the tires and had accepted them for a fee of more than 2 million DKK (0.3 million EUR), media said.

Figure 6 – Piles of unprocessed tires, Jan 2023
